# **Navajo Abandoned Uranium Mine**

## **Site Screen Report**

## **Jefferson Canyon No. 1 AUM Site**

**January 2011**

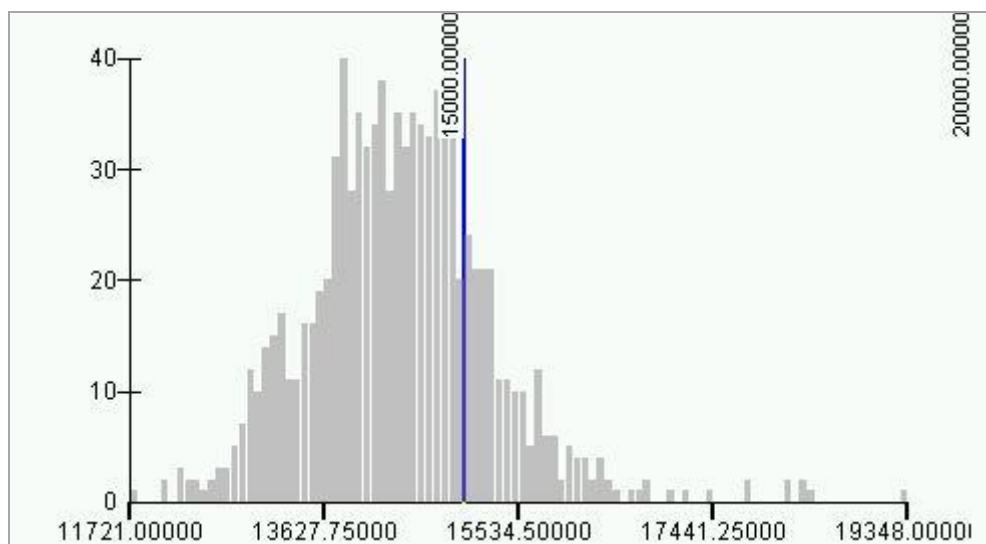
The following chart and statistics were generated by ESRI ArcGIS 9.3.1, and show the general distribution of the site gamma radiation measurements. The horizontal X axis represents the gamma radiation reading levels in cpm (lowest levels to the left). The vertical Y axis represents the frequency of each gamma radiation level.

Count:	953
Minimum:	11721.00000
Maximum:	19348.00000
Sum:	13702925.00000
Mean:	14378.72508
Median:	14361.00000
Standard Deviation:	904.38530

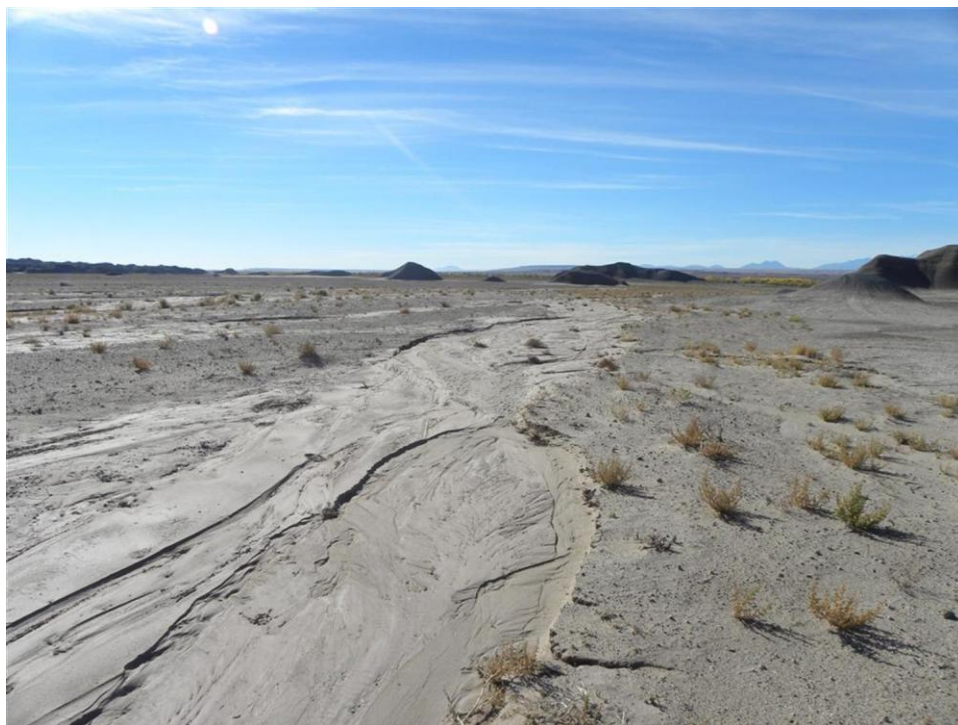
Photo 1. Jefferson Canyon No. 1 mine site

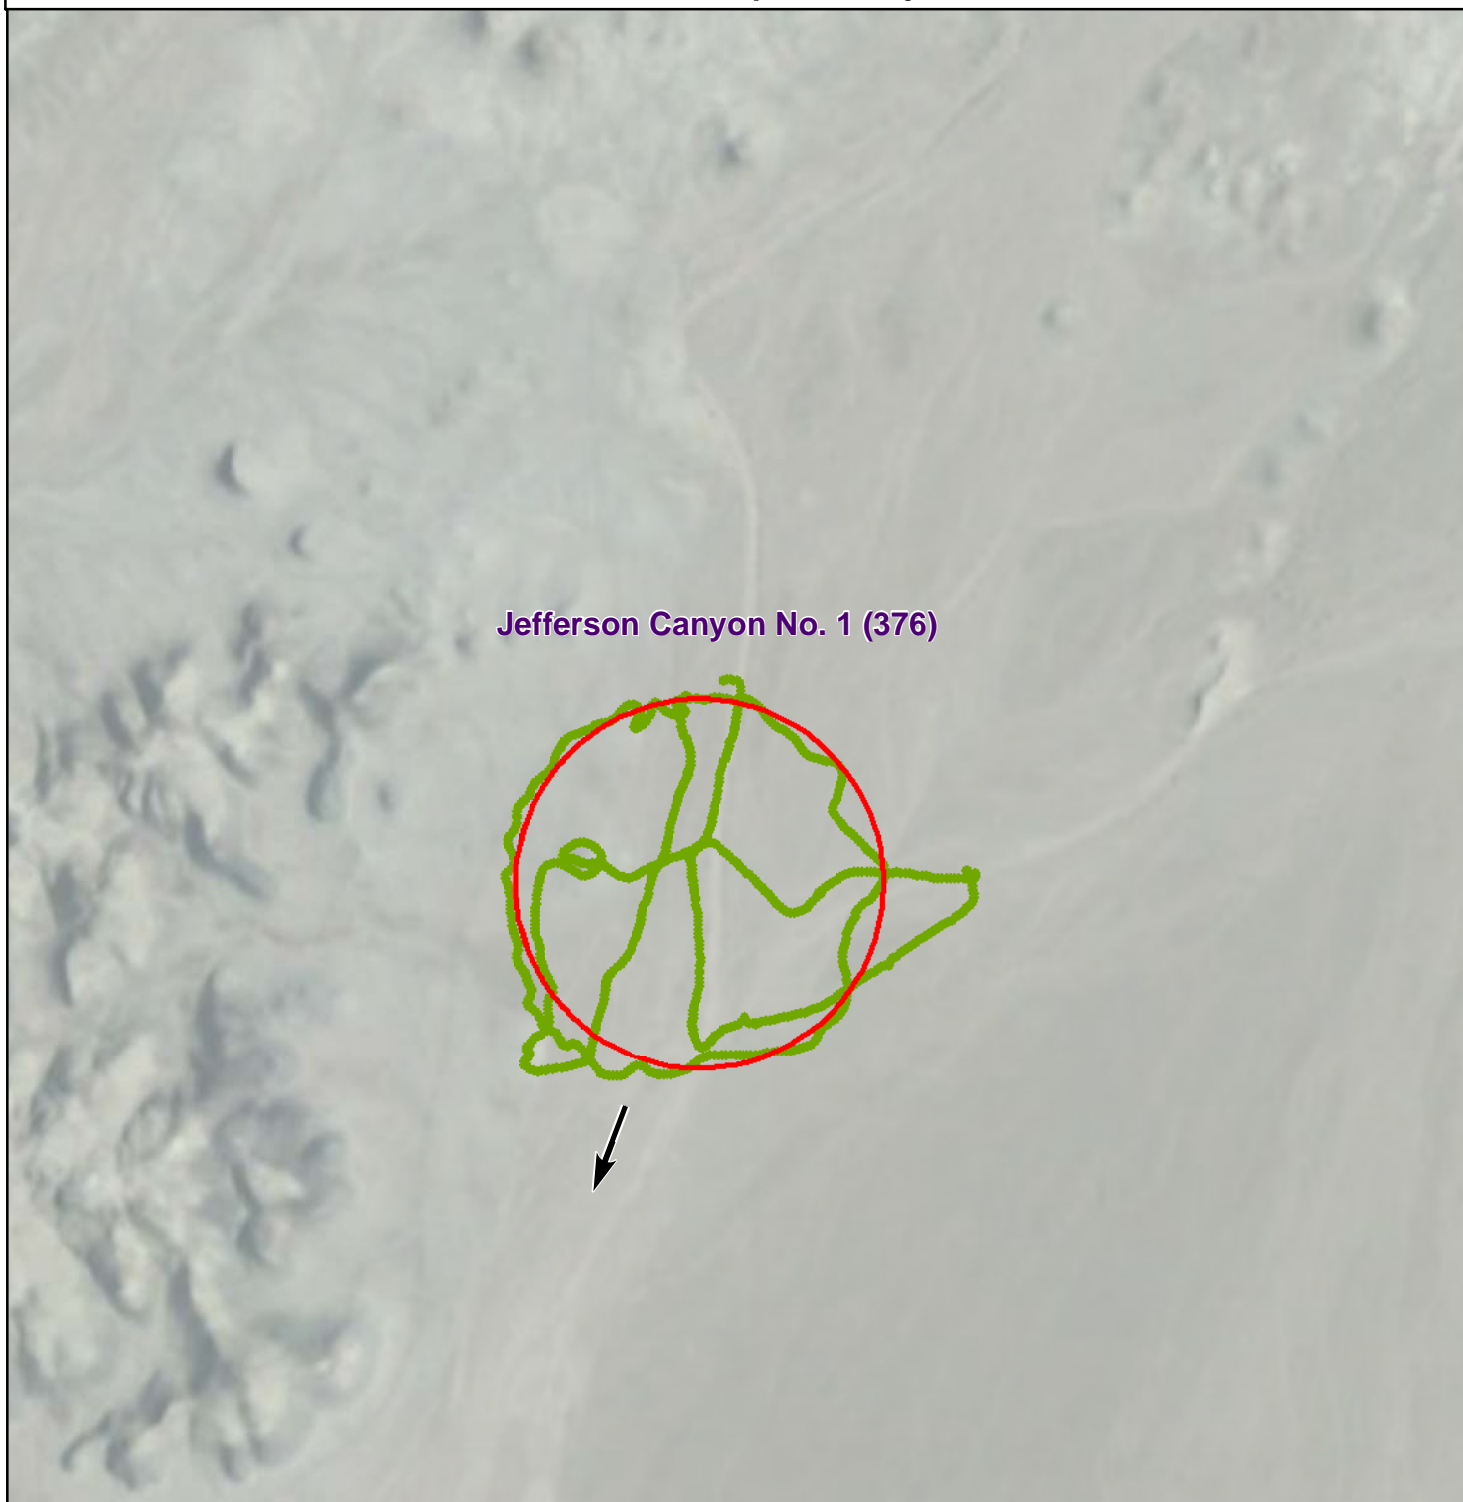
**Figure 1 - Gamma Radiation Measurements, Above Two Times  
Jefferson Canyon No. 1 (376)  
Coalmine Mesa Chapter, Navajo Nation**

Gamma survey conducted 11/2010  
Measured as counts per minute (cpm)

Average background 14,278 cpm

A total of 953 gamma radiation measurements were collected from the mine site, ranging from 11,721 cpm to 19,348 cpm. The measurements are represented in Figures 1 and 2.

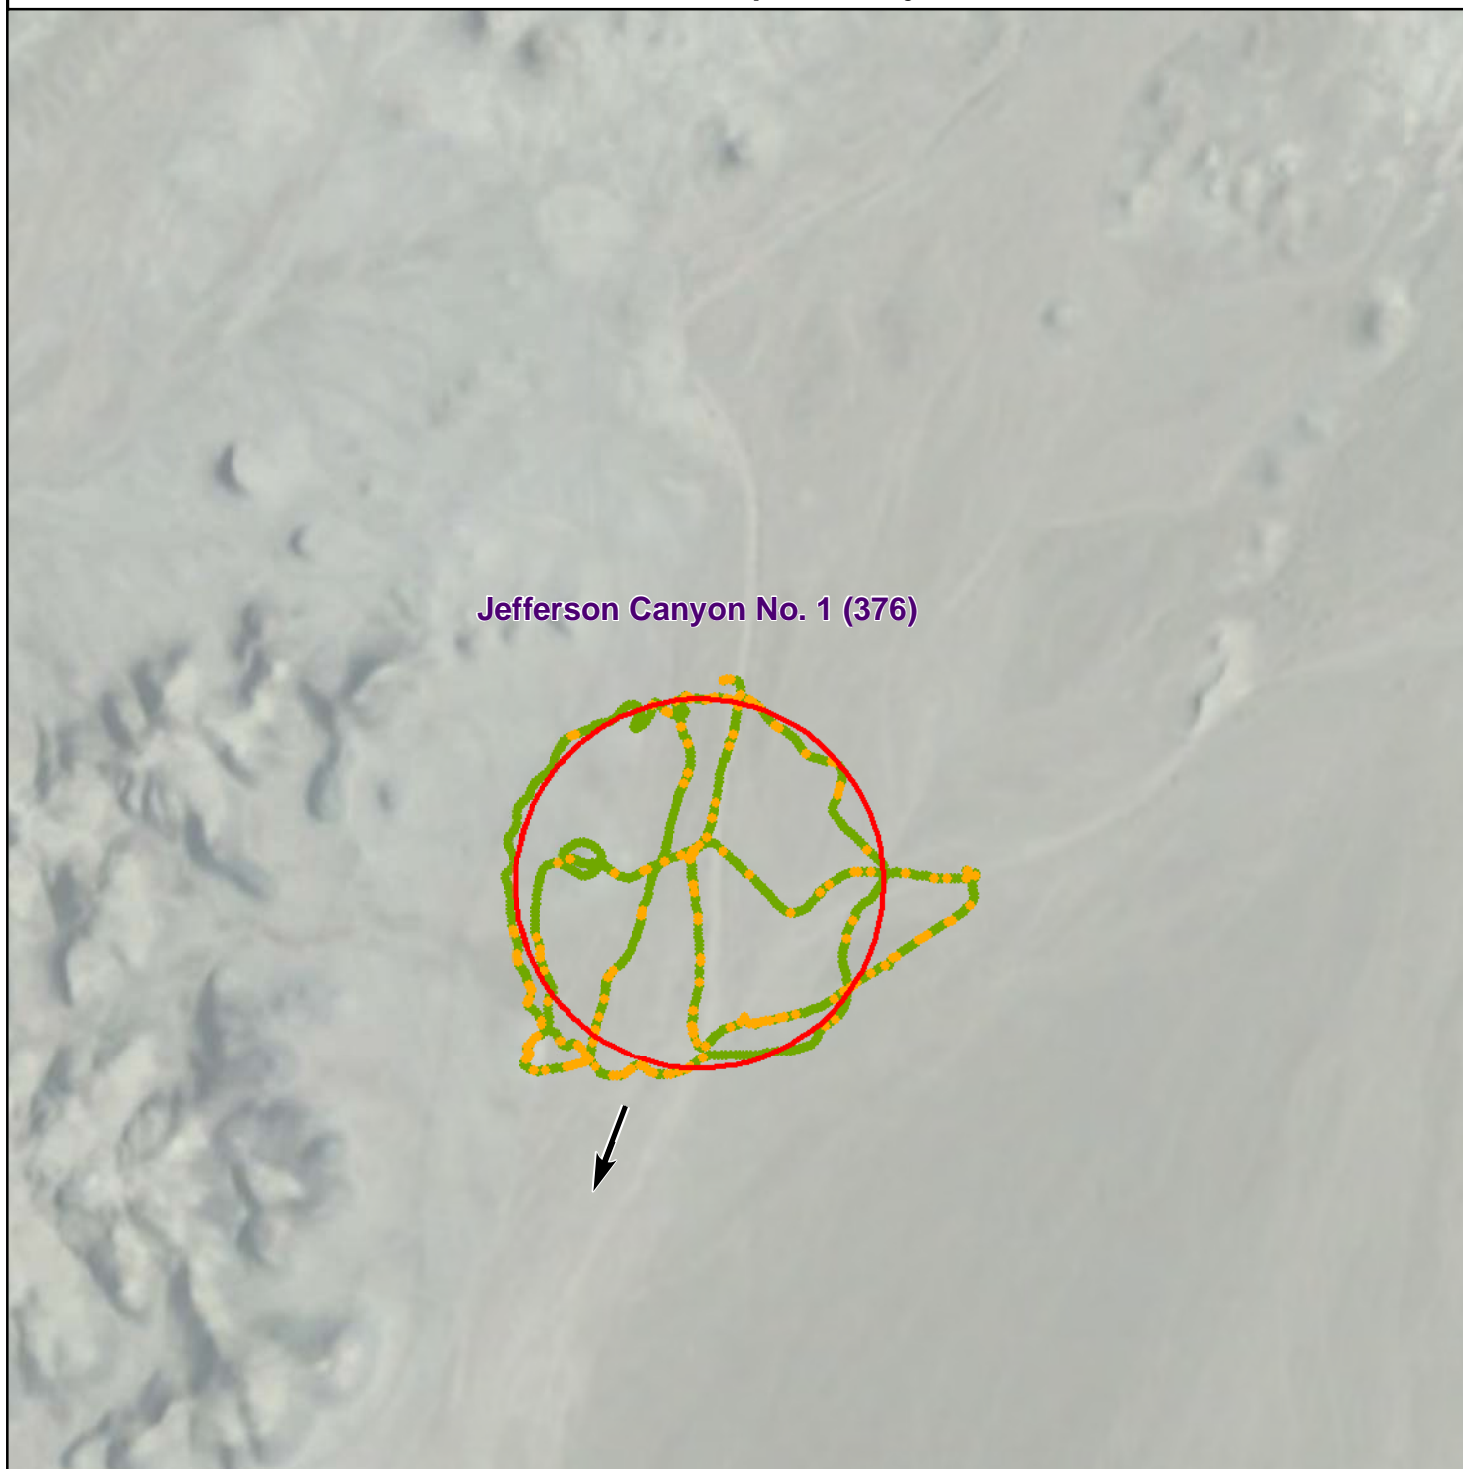
**Figure 2 - Gamma Radiation Measurements  
Jefferson Canyon No. 1 (376)  
Coalmine Mesa Chapter, Navajo Nation**

**Gamma survey conducted 11/2010  
Measured as counts per minute (cpm)**

**Average background 14,278 cpm**
